Sunnyslope Water District

3570 Airline Highway

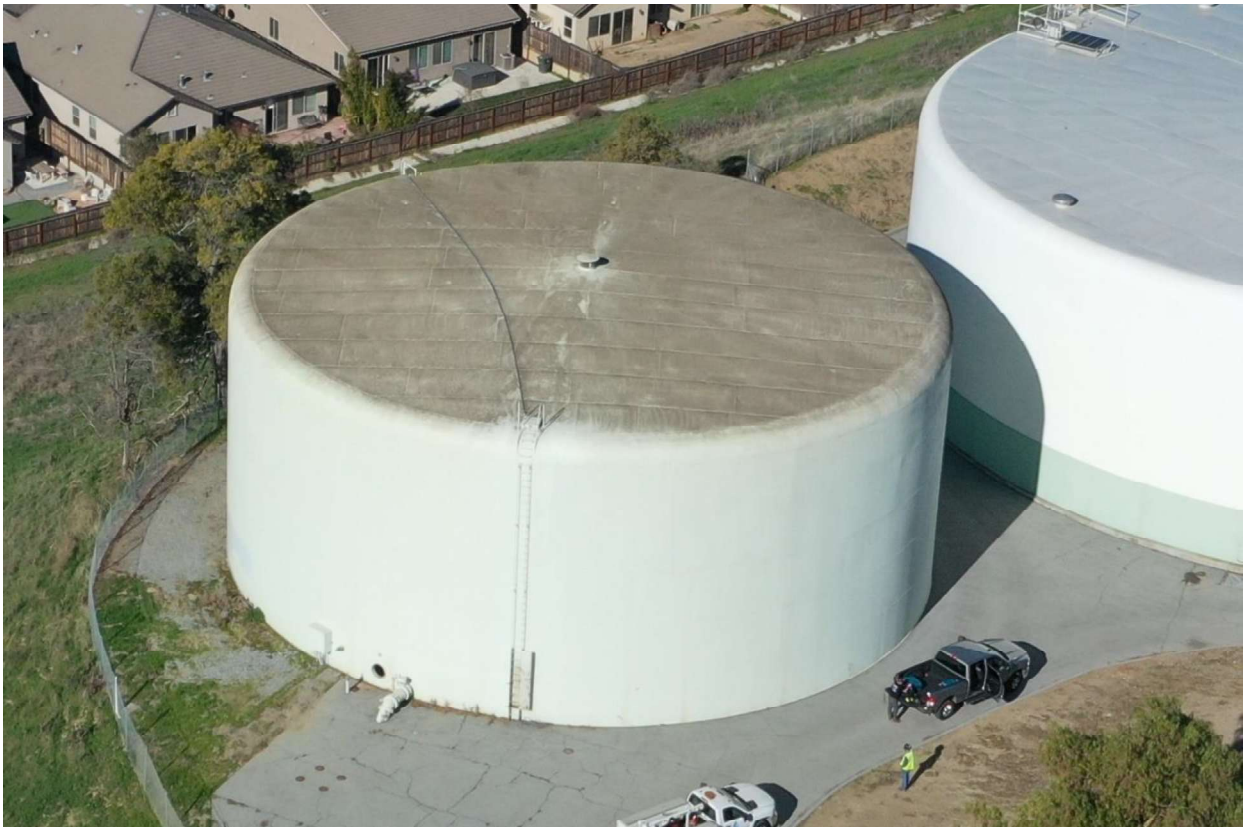
E-2 Same as Photo E-1, except a closer view of the roof.

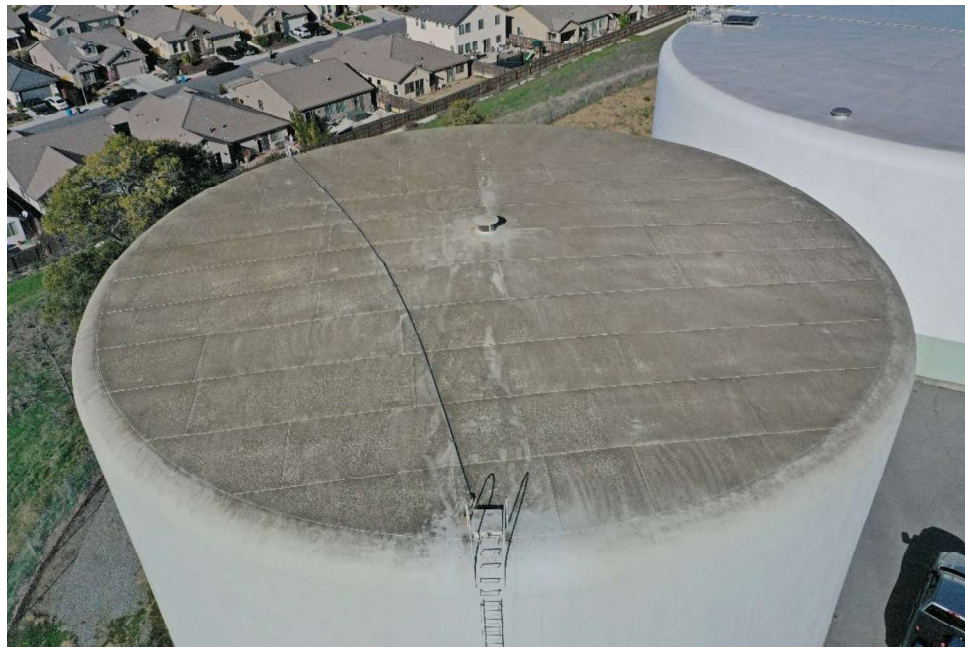
E-3 View of the center vent, illustrating minor corrosion on the vent cover and brackets.

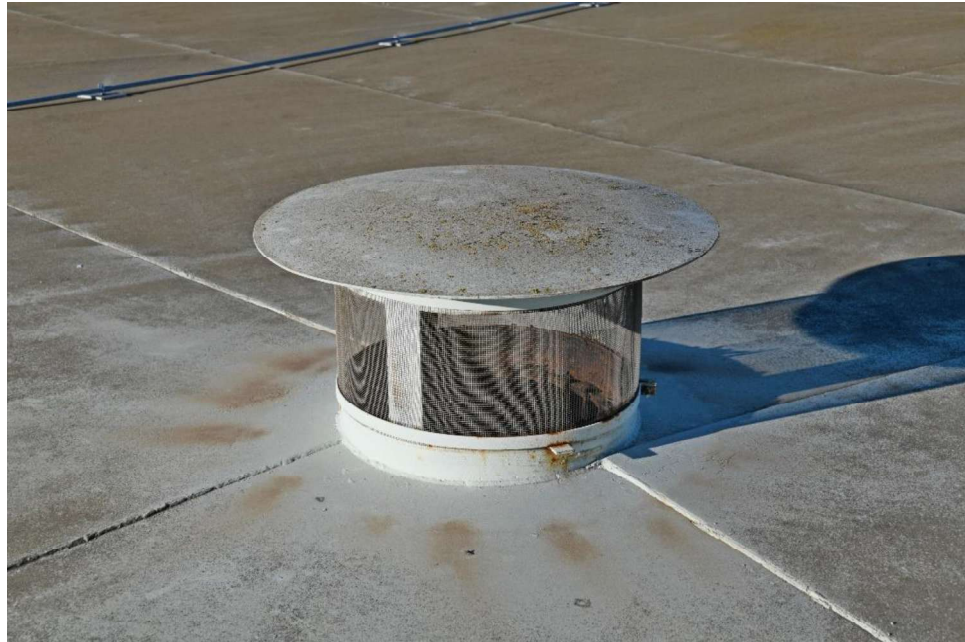
E-4 Same as Photo E-3, except a closer view of the vent neck.

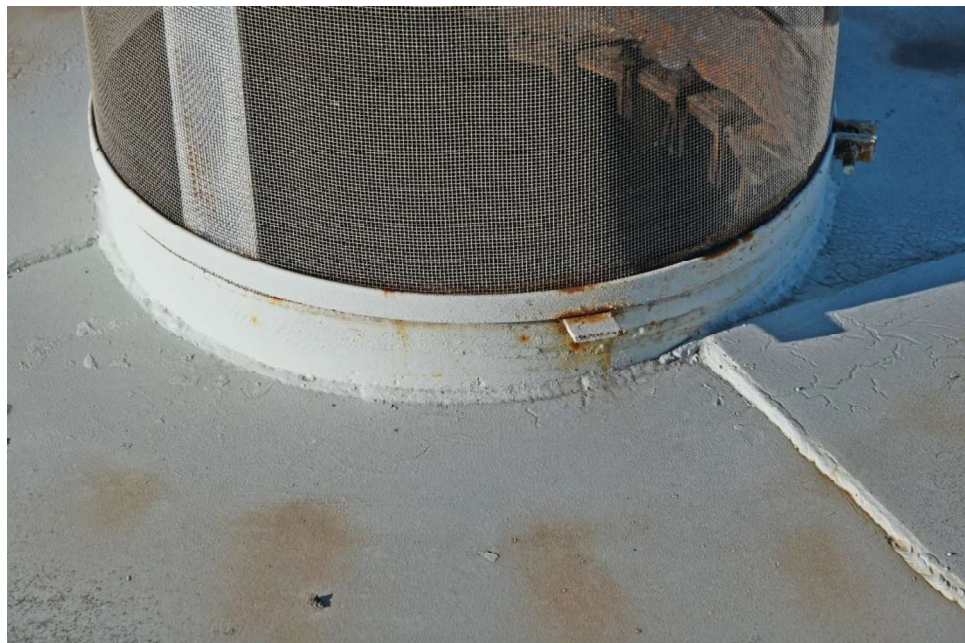
E-5 View of the underside of the center vent cover, illustrating moderate corrosion on the vent cover and brackets.

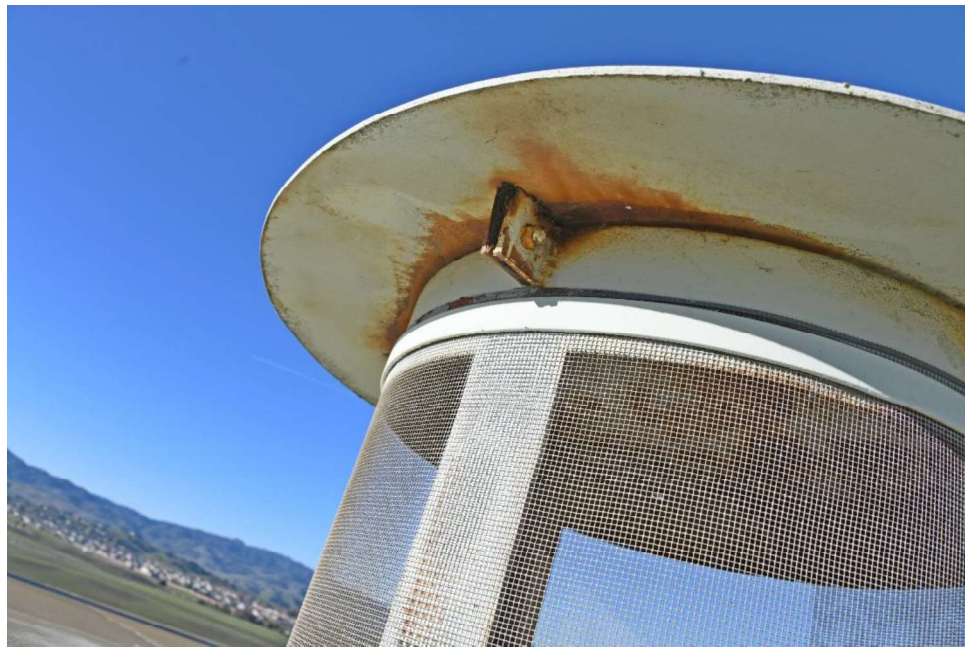
E-6 View of a portion of the roof, illustrating a layer of dirt and what appears to be yellow lichen growing on the roof plates.

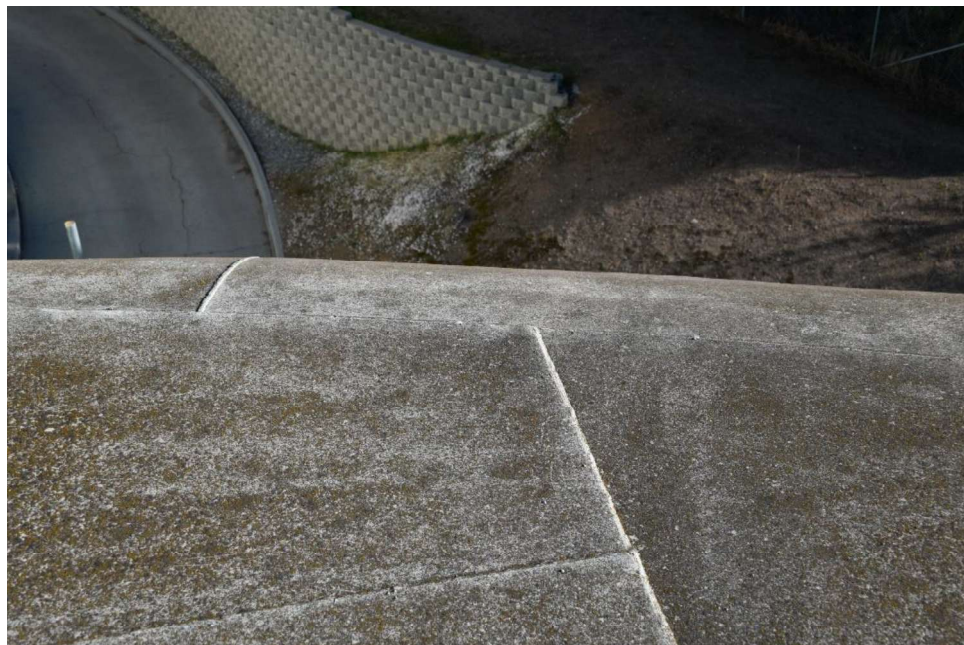
E-11 View of the liquid level indicator (LLI) pipe and conduit, illustrating generally good condition of all surfaces. Note heavier yellow lichen around the LLI pipe.

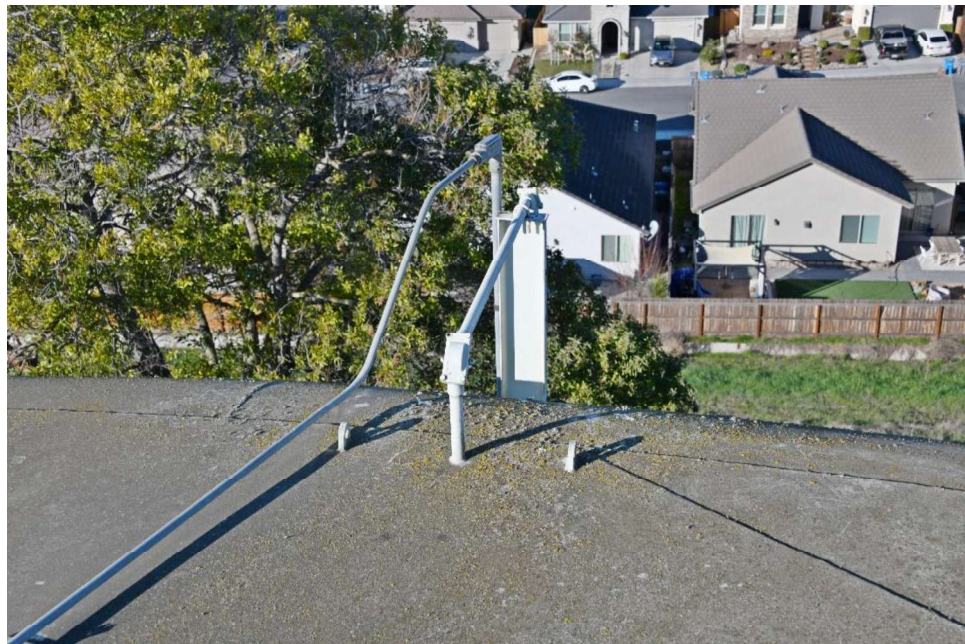
E-12 View of the roof hatch, illustrating severe oxidation and fading of the visible portion of the paint system.

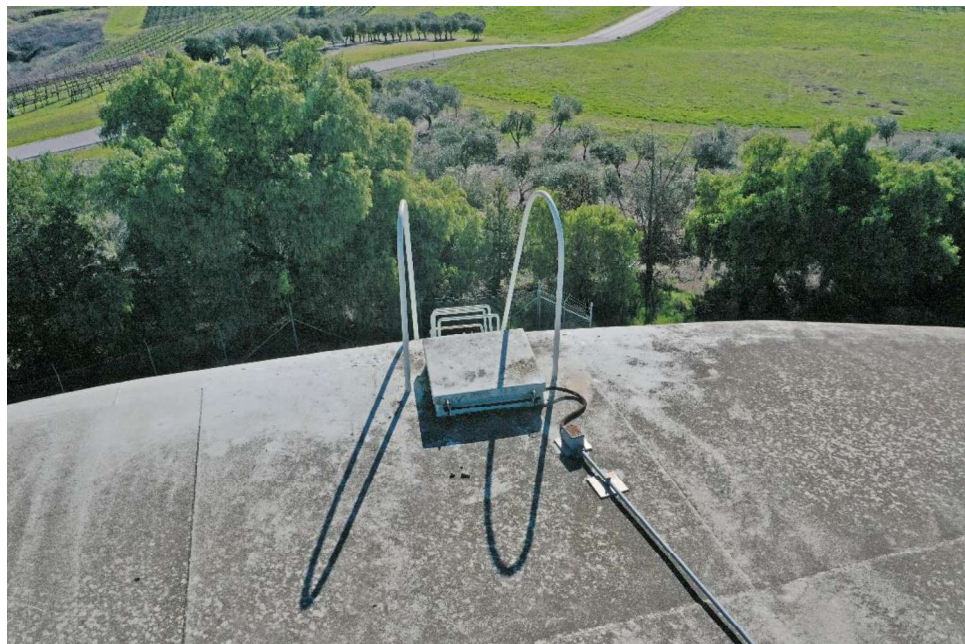
E-13 View of the underside of the roof hatch cover, illustrating moderate to severe corrosion on the cover and hinge pin.

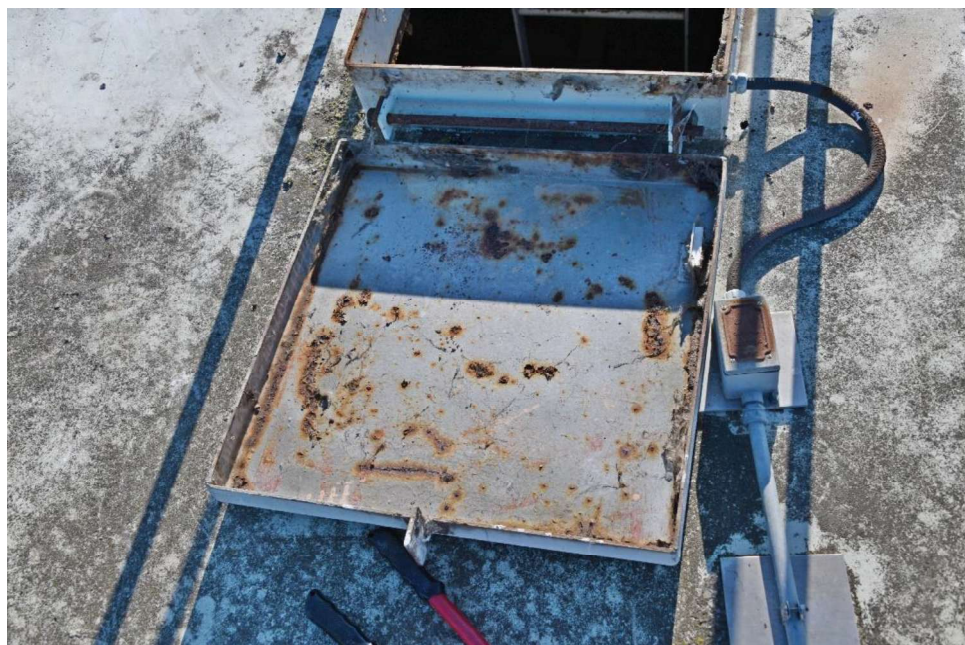
E-14 View of the top of the ladder, illustrating severe oxidation and fading and otherwise generally good condition of the paint system.

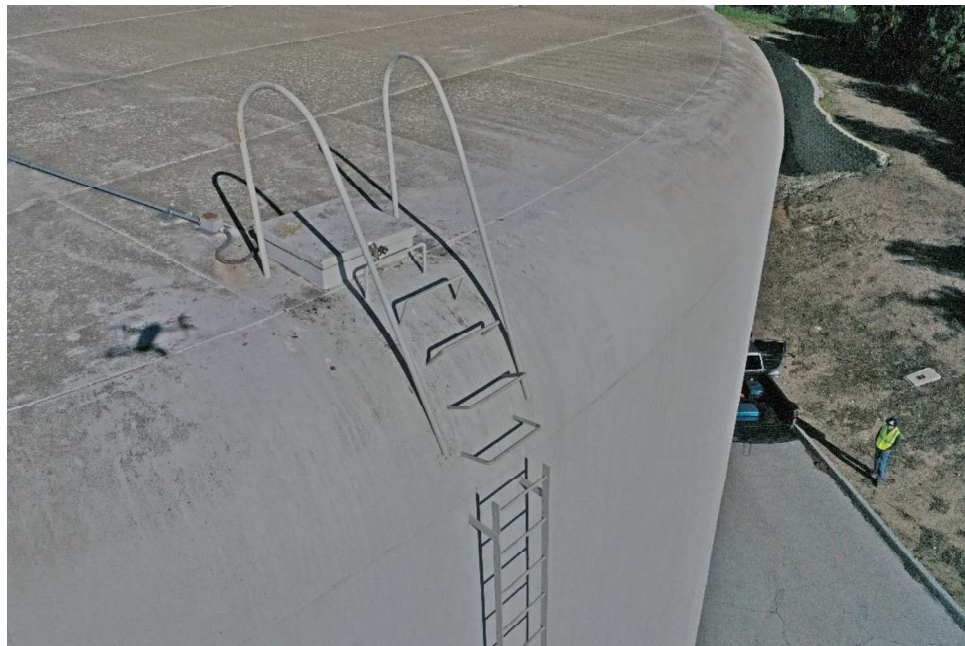
E-15 View of the bottom of the ladder, illustrating dirt and debris behind the ladder vandal guard and otherwise generally good condition of the paint system.

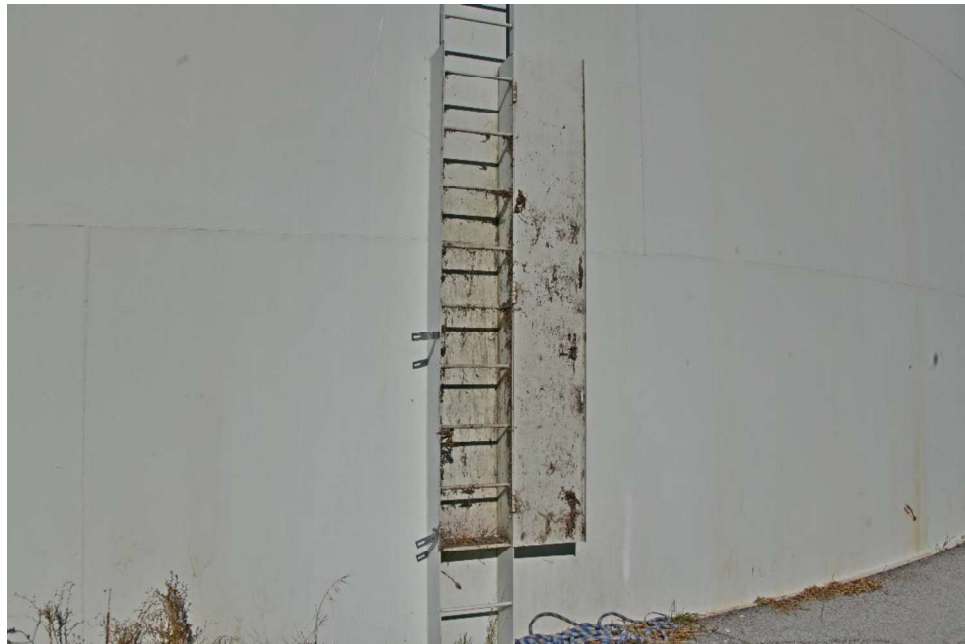
E-16 View of a portion of the shell, illustrating moderate to severe oxidation and fading and otherwise generally good condition of the paint system.

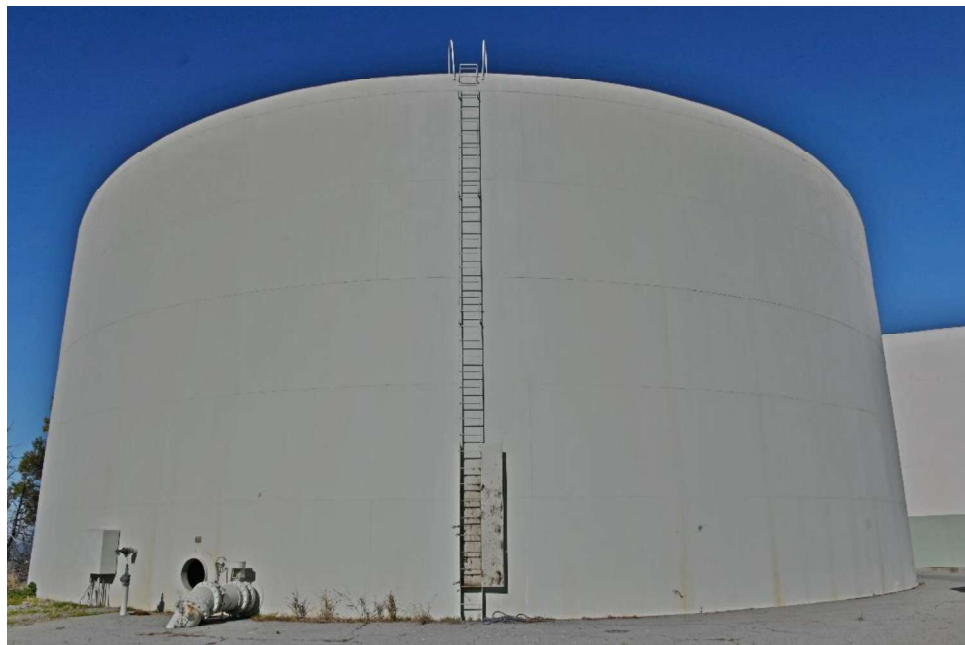
E-17 Same as Photo E-16, except in a different location. Note paint patchwork on the lower shell.

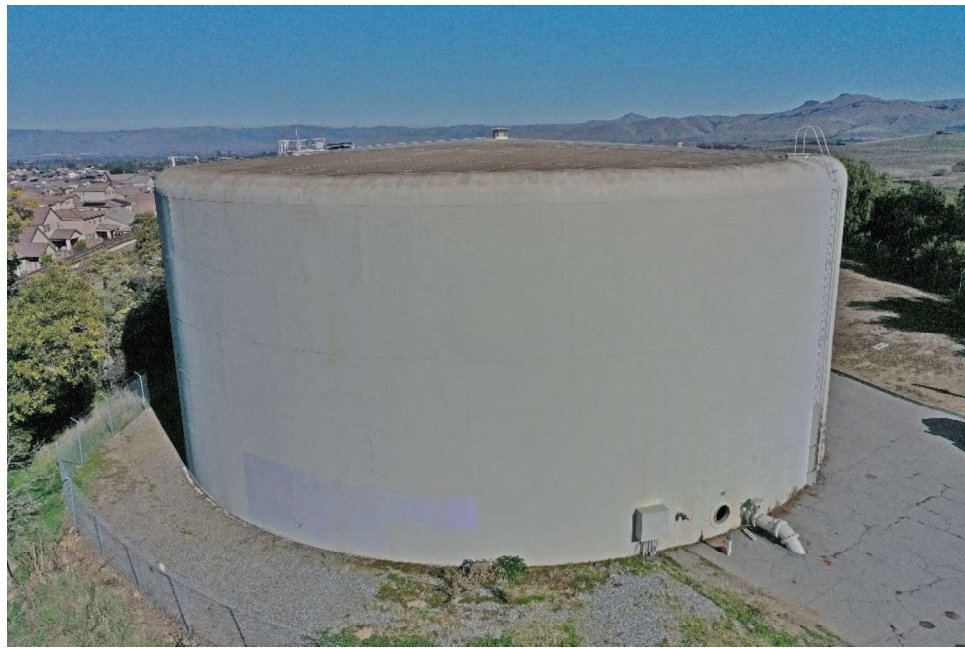
E-18 View of knuckle plates, illustrating exposed prime and intermediate coats with minor general corrosion present.

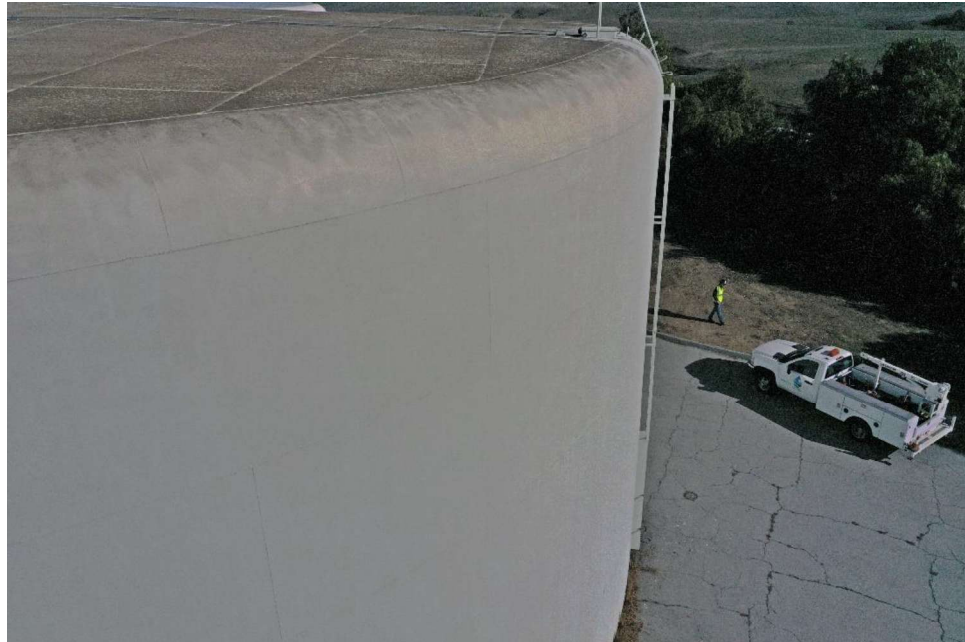
E-19 View of the lower shell, illustrating an area of paint patchwork. Note generally good condition of the adjacent paint system.

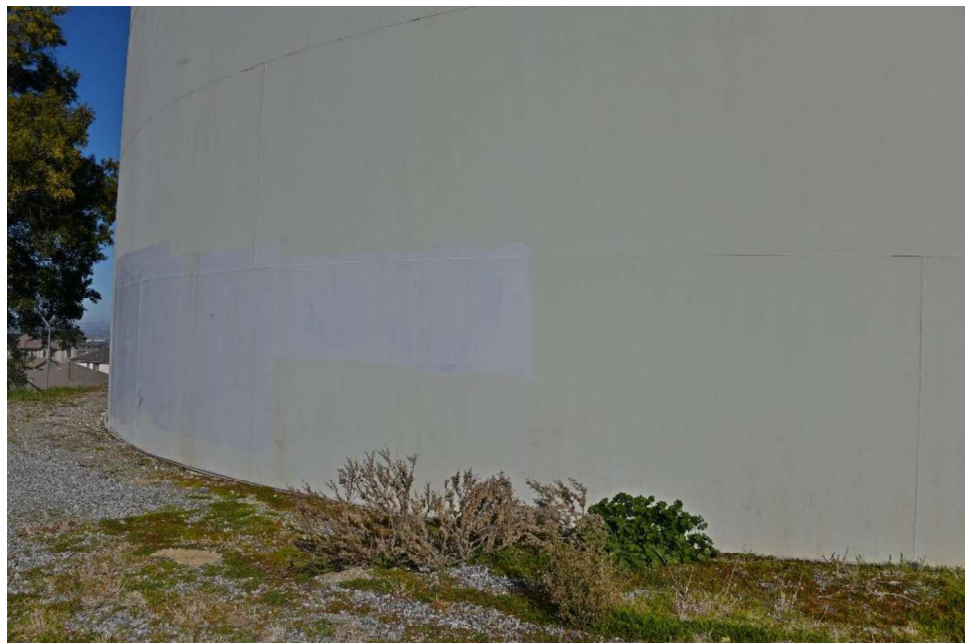
E-20 View of the LLI gauge board, illustrating minor fading of the numbering on the gauge board. Note top portion of the gauge board is missing.

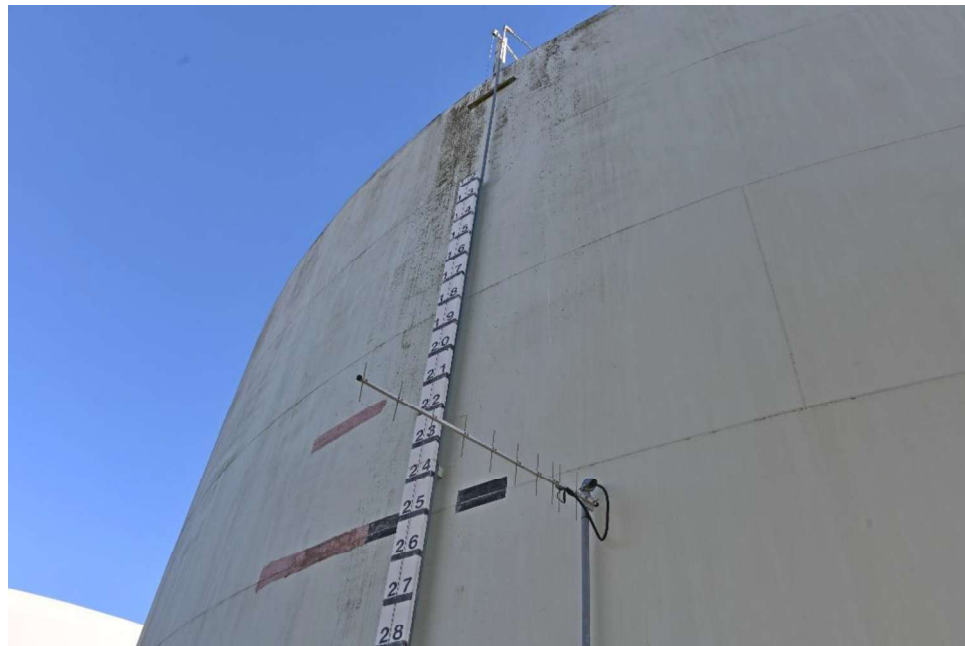
E-21 Same as Photo E-20, except at the bottom of the LLI gauge board. Note fair to good condition of the adjacent equipment boxes and conduit.

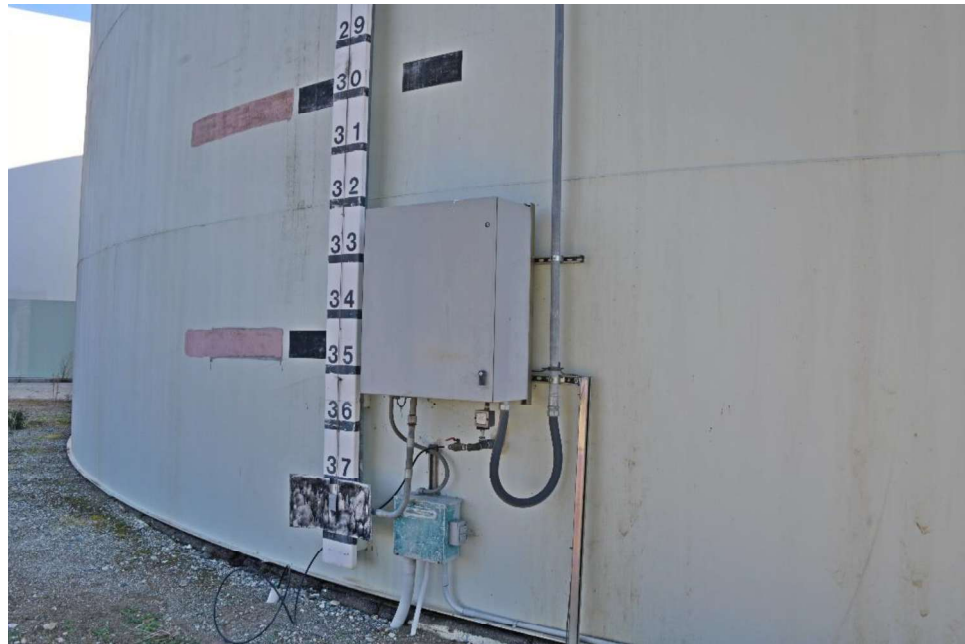
E-22 View of the manhole, illustrating mechanical damage with minor corrosion on the stiffener ring and staining on the adjacent shell.

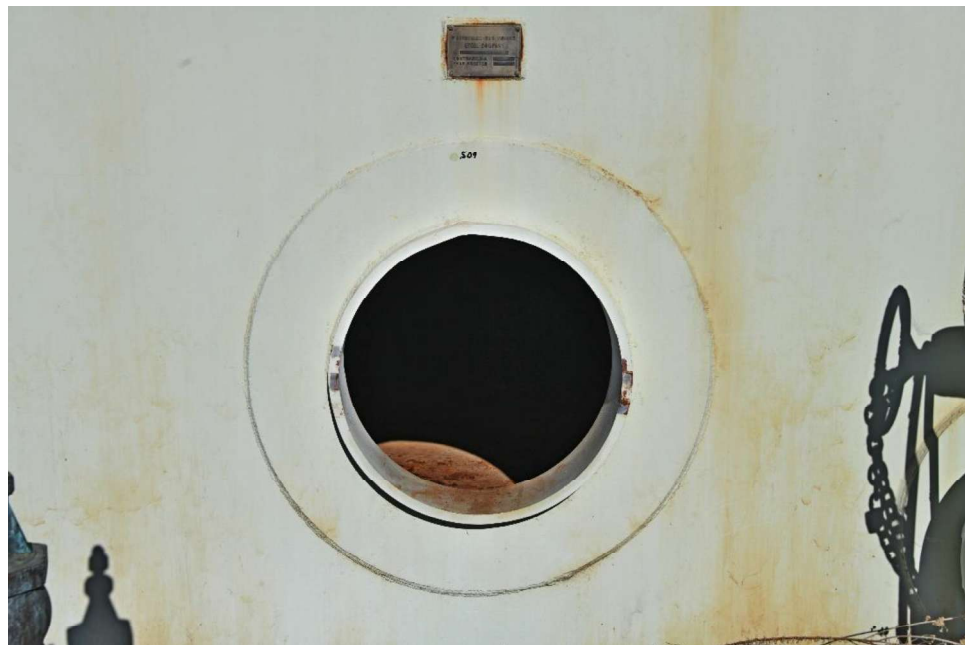
E-23 View of the identification plate, illustrating minor to moderate corrosion along the edge of the plate.

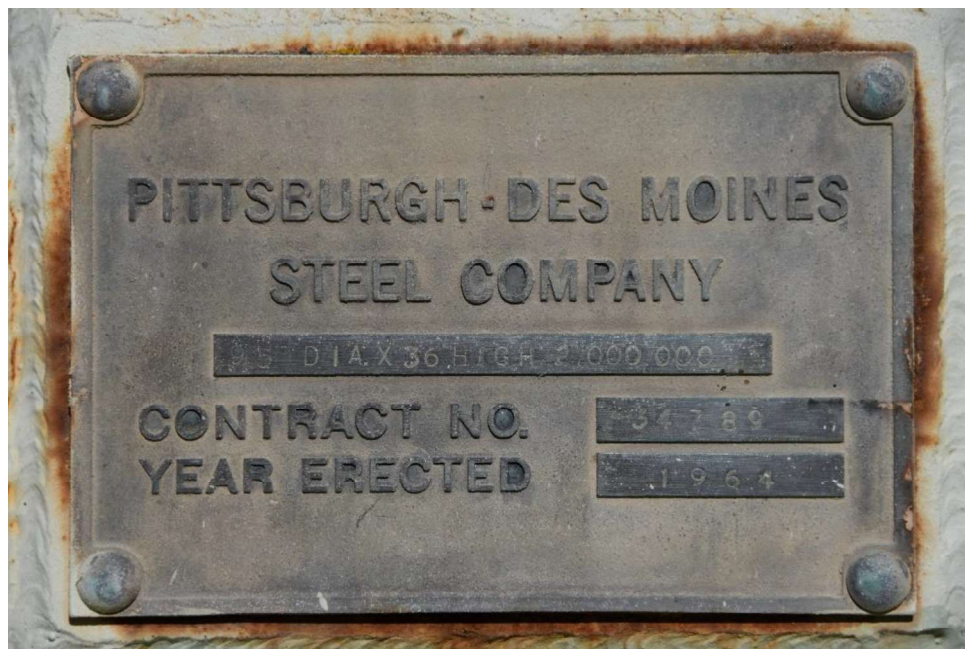
E-24 View of the inlet/outlet, illustrating random minor corrosion on the pipe, flanges, and valve actuator.

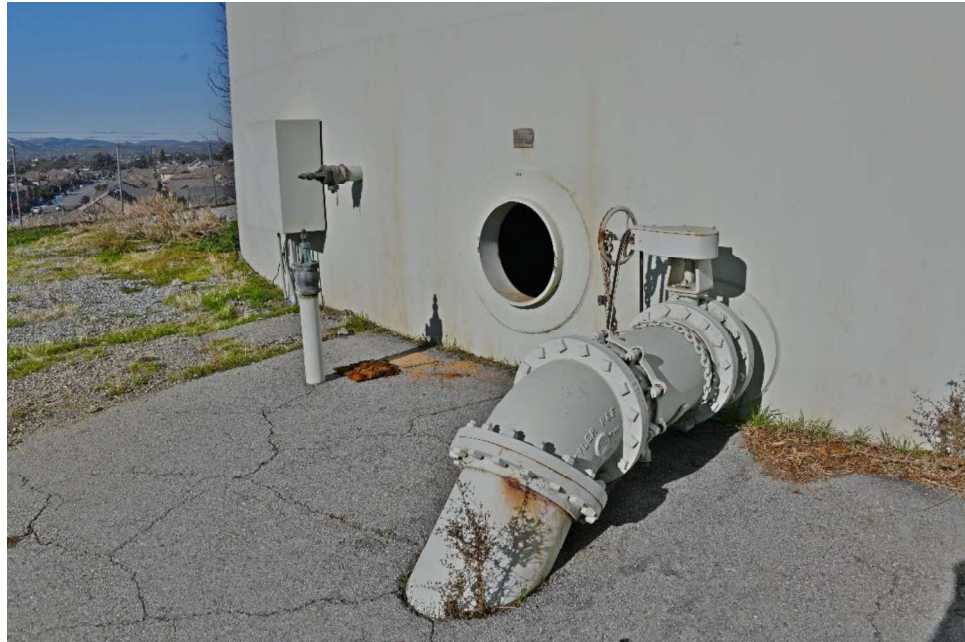
E-25 View of a small diameter penetration, illustrating generally good condition of the brass valve and adjacent paint system.

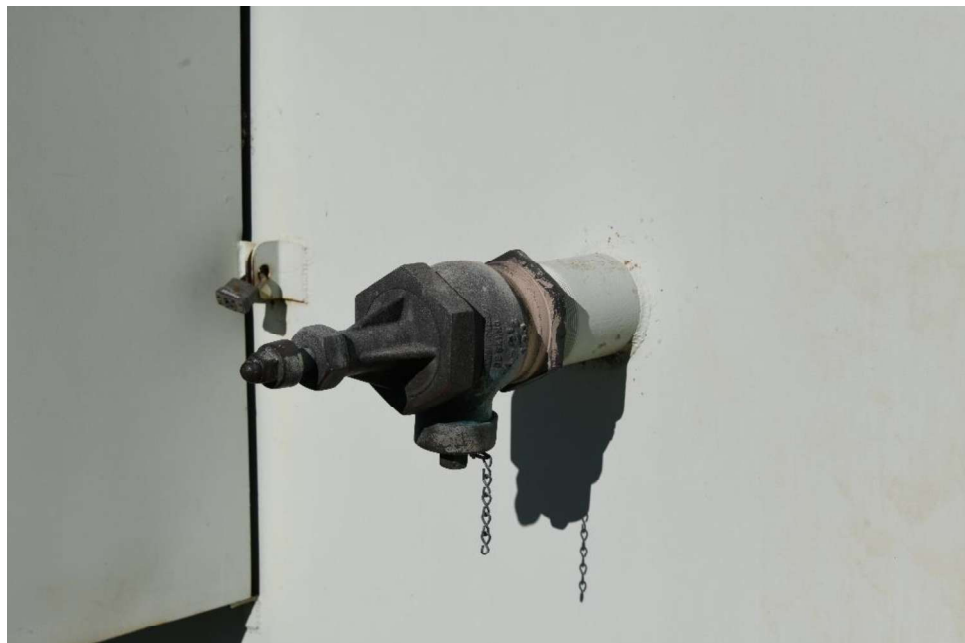
E-26 View of the bottom plate extension, illustrating minor corrosion along the edge of the plate.

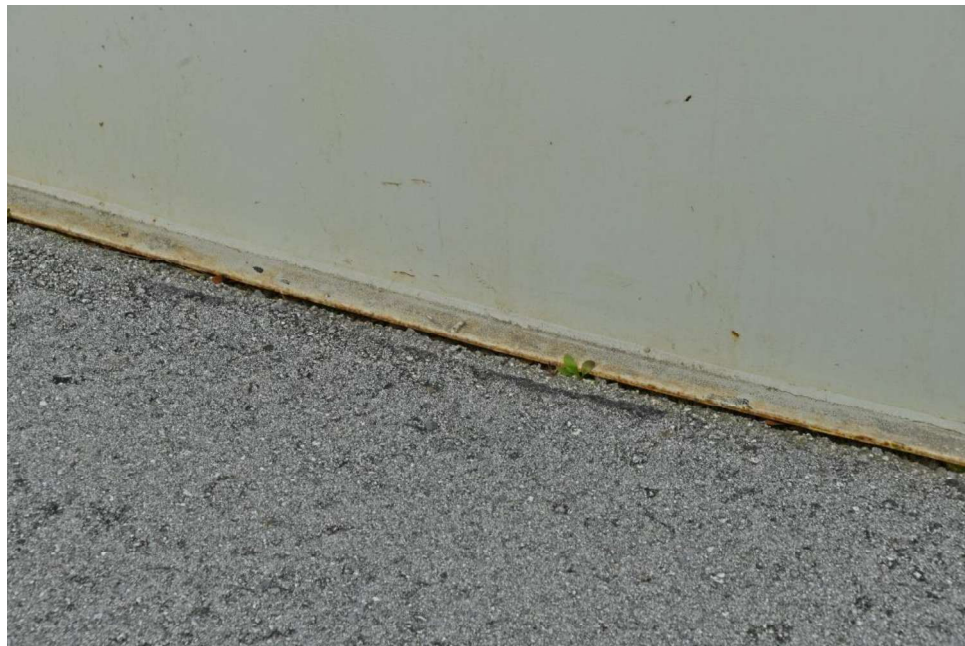
E-27 Same as Photo E-26, except in a different location. Note large gap under the tank in this location.

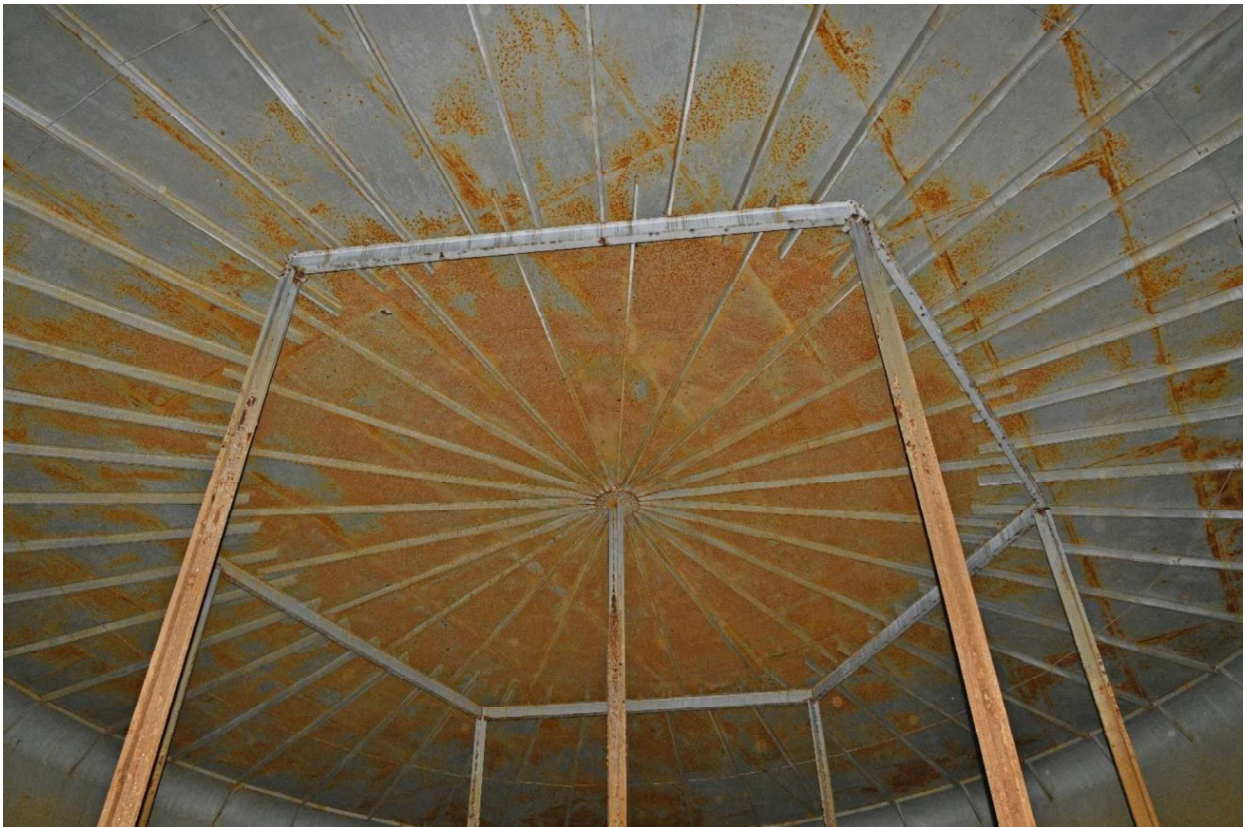
I-2 Same as Photo I-1, except a closer view of the inner bay.

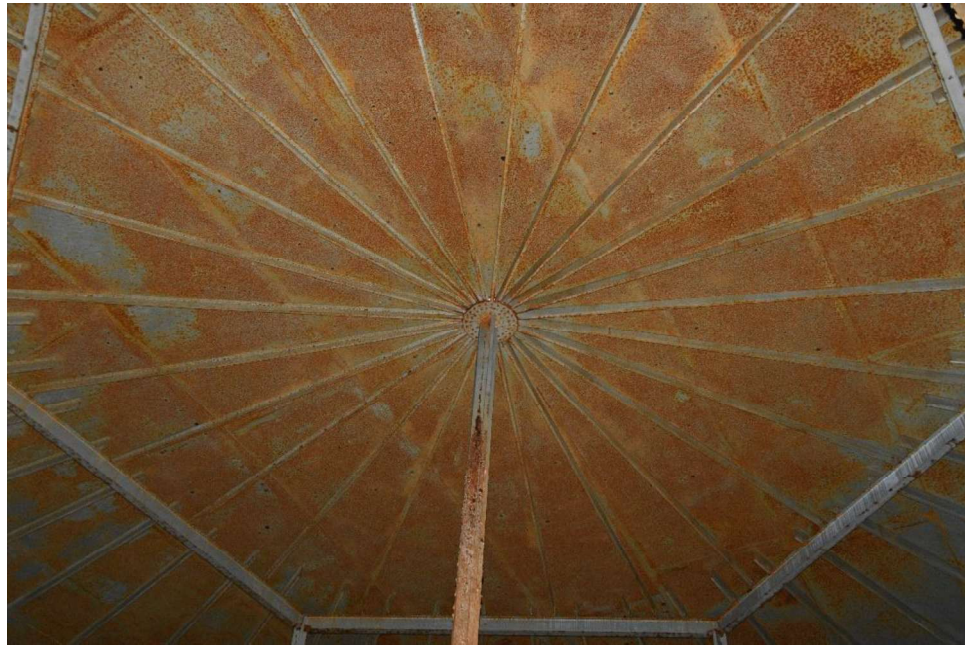
I-3 View of the center support plate, illustrating blistering of the silver coating system with minor to moderate corrosion on all surfaces.

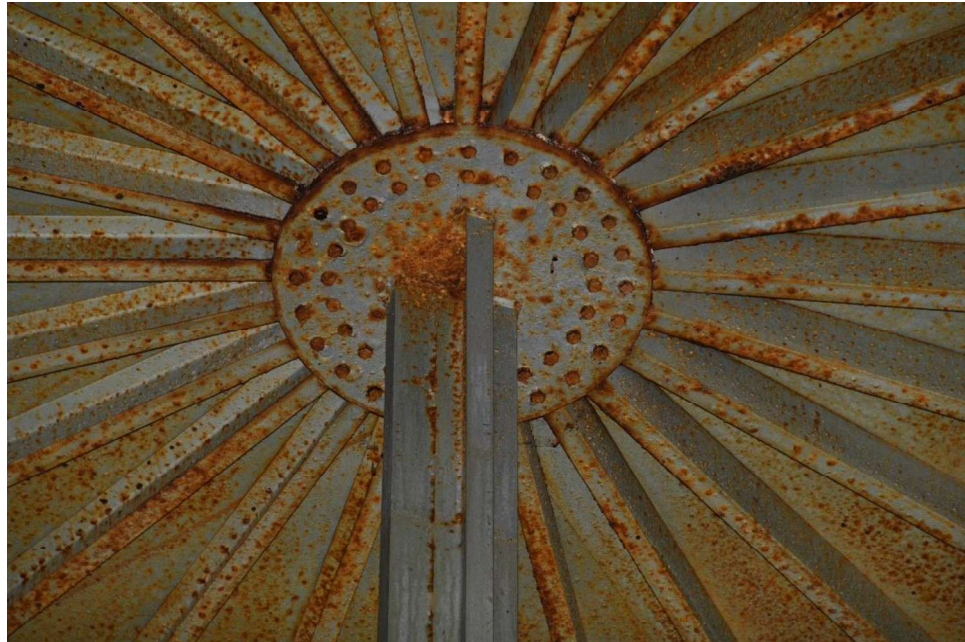
I-4 View of a portion of the inner bay, illustrating general corrosion on the roof and rafters.

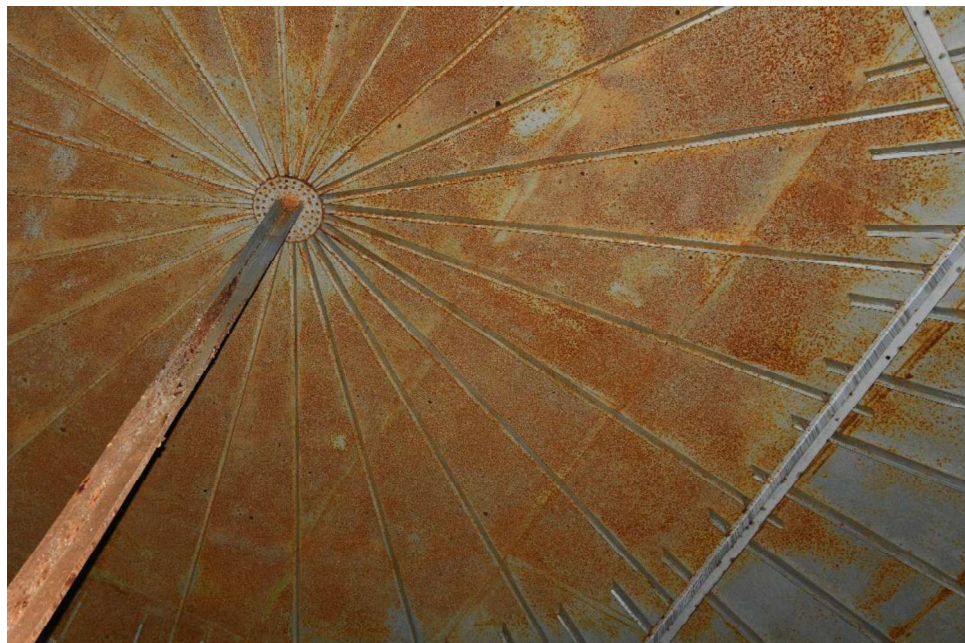
I-5 Same as Photo I-4, except a different portion of the inner bay.

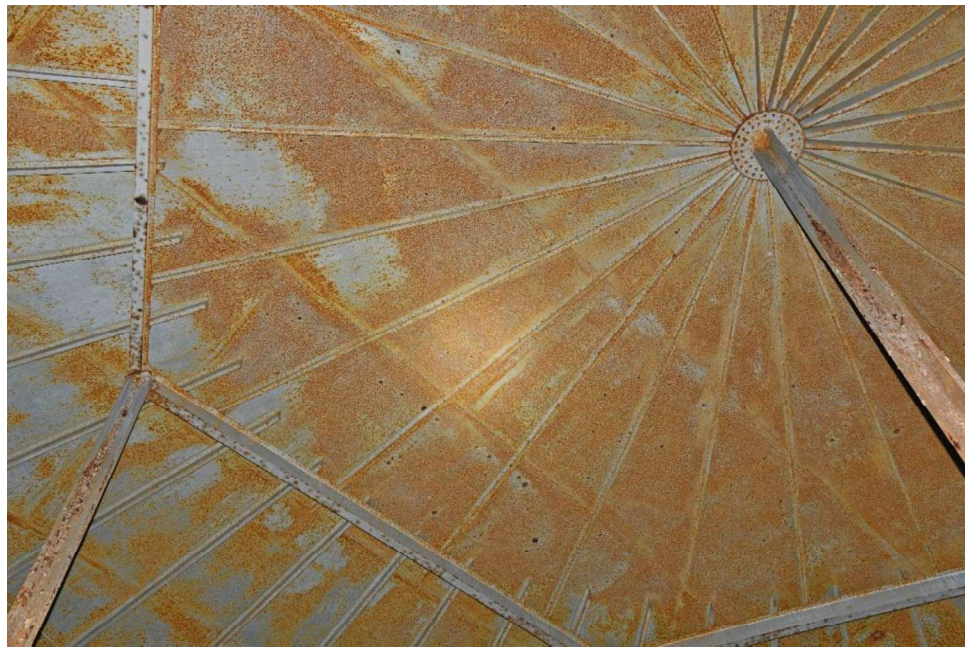
I-6 View of a portion of the outer bay, illustrating moderate to severe general corrosion on the roof and minor corrosion on the rafters.

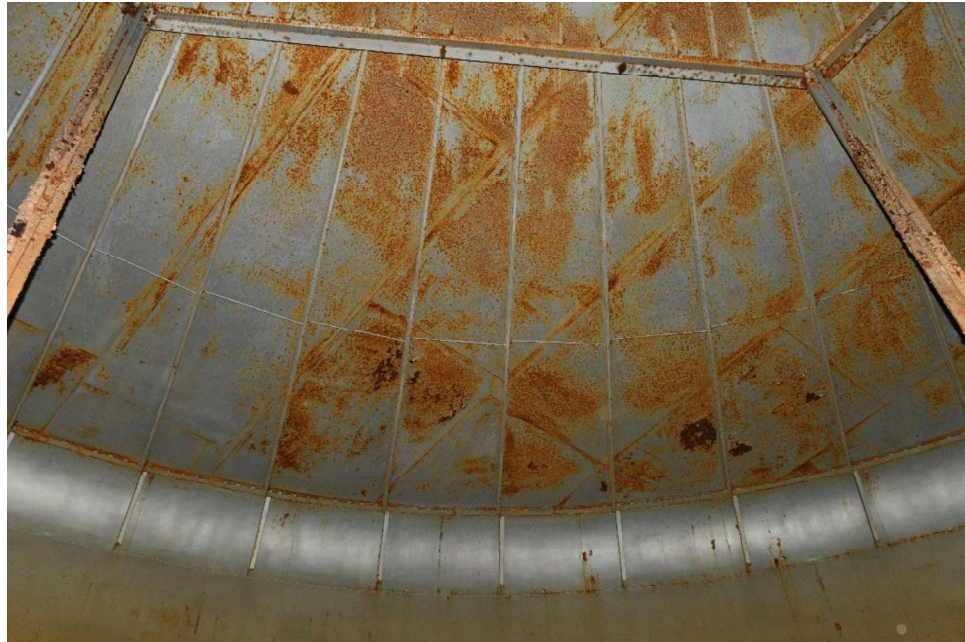
I-7 Same as Photo I-6, except in a different location.

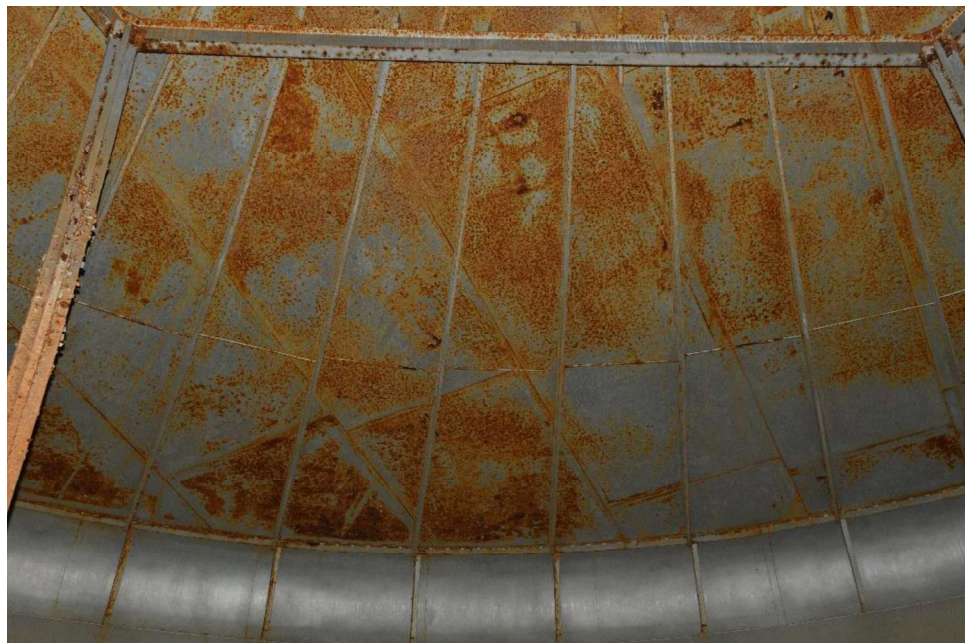
I-8 View of a girder, illustrating minor to moderate corrosion on the girder web and flanges.

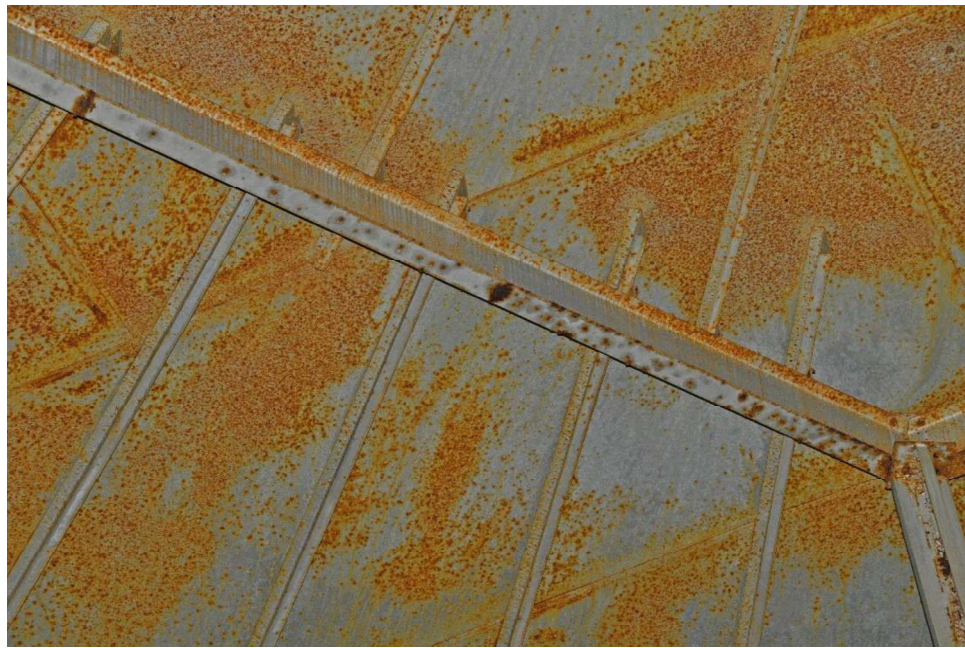
I-9 View of a girder to column connection, illustrating severely corroded nuts and bolts securing the connection.

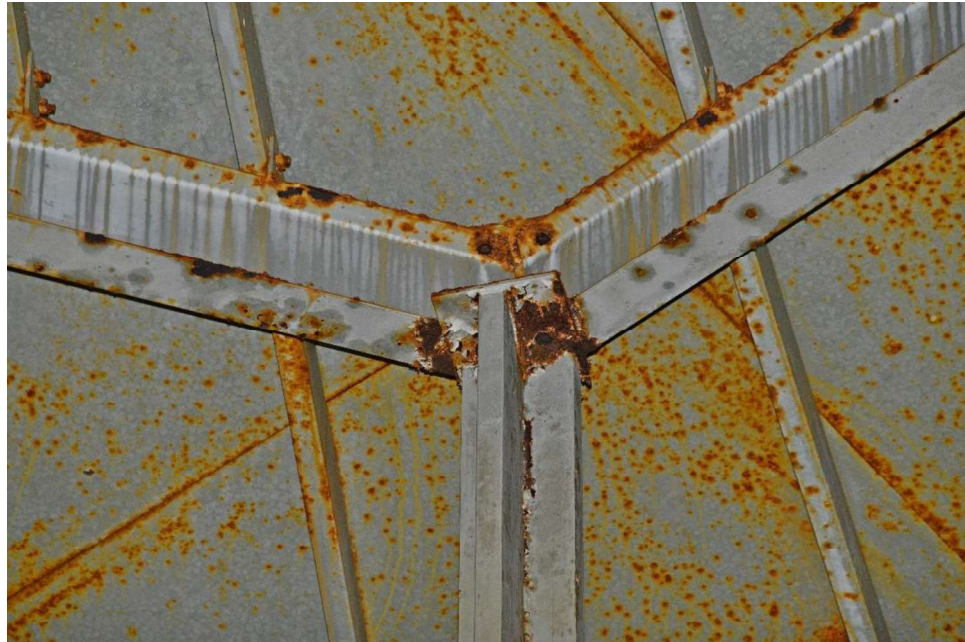
I-10 Close-up view of the roof, illustrating moderate to severe corrosion on the roof plates and along the roof to shell transition.

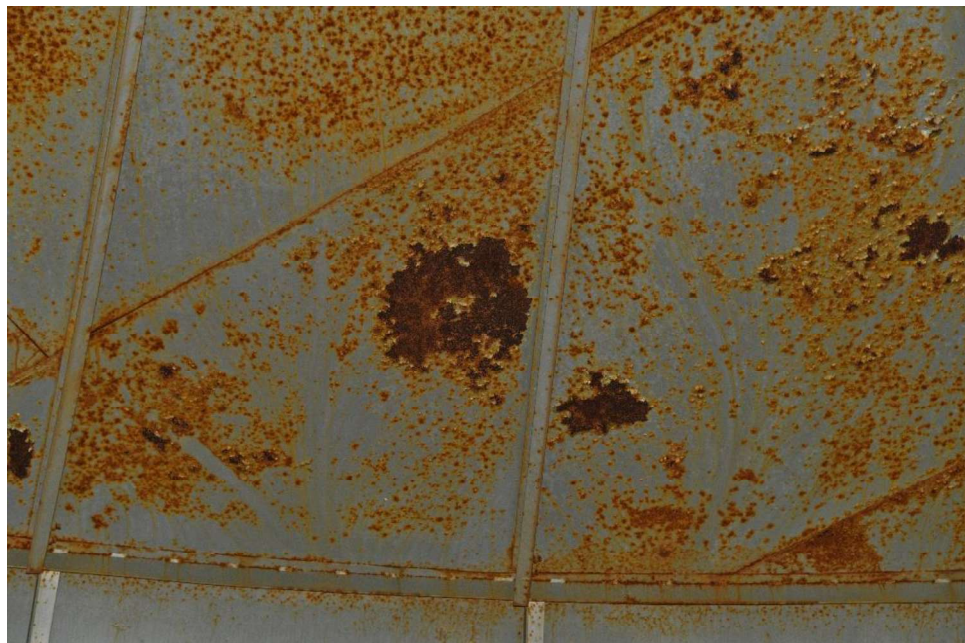
I-11 Same as Photo I-10, except in a different location.

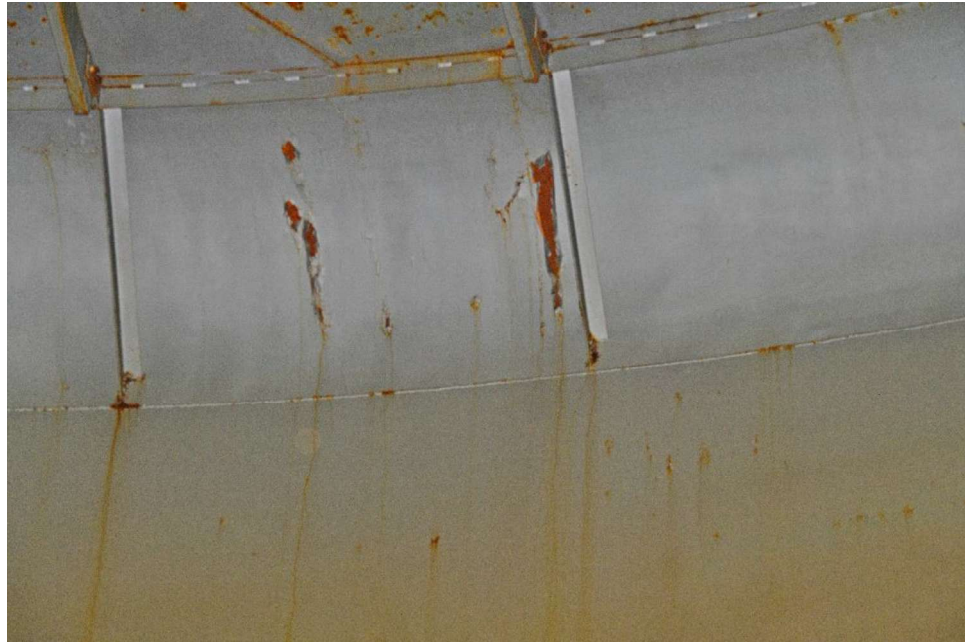
I-13 View of the roof hatch and overflow, illustrating moderate to severe corrosion along the edges of the roof hatch curb, overflow weir box and pipe, and ladder.

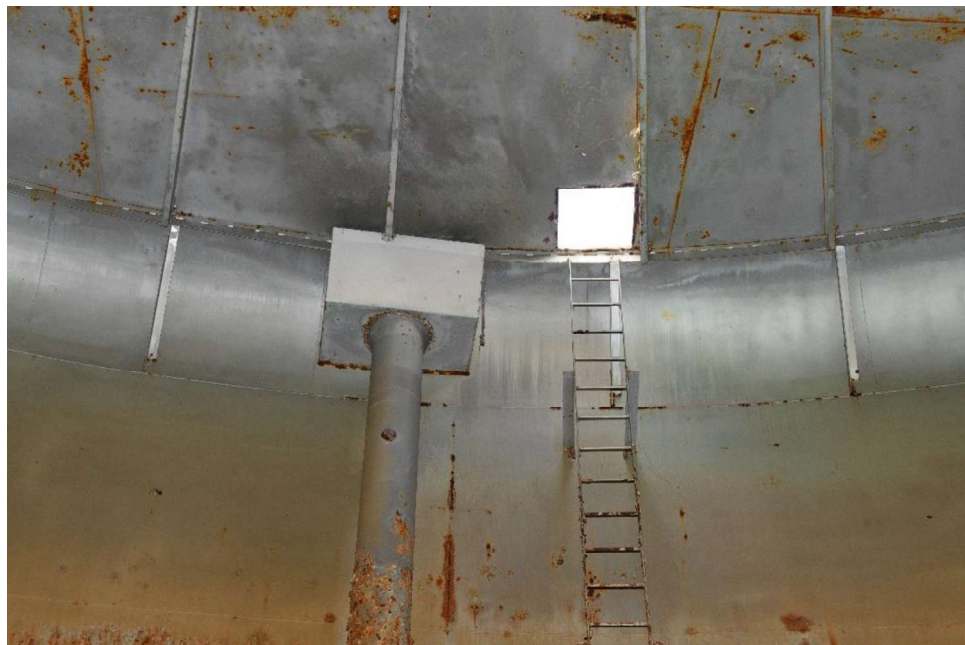
I-14 View of the ladder, shell, and overflow pipe, illustrating moderate to severe corrosion on all surfaces.
