Sunnyslope Water District

3570 Airline Highway

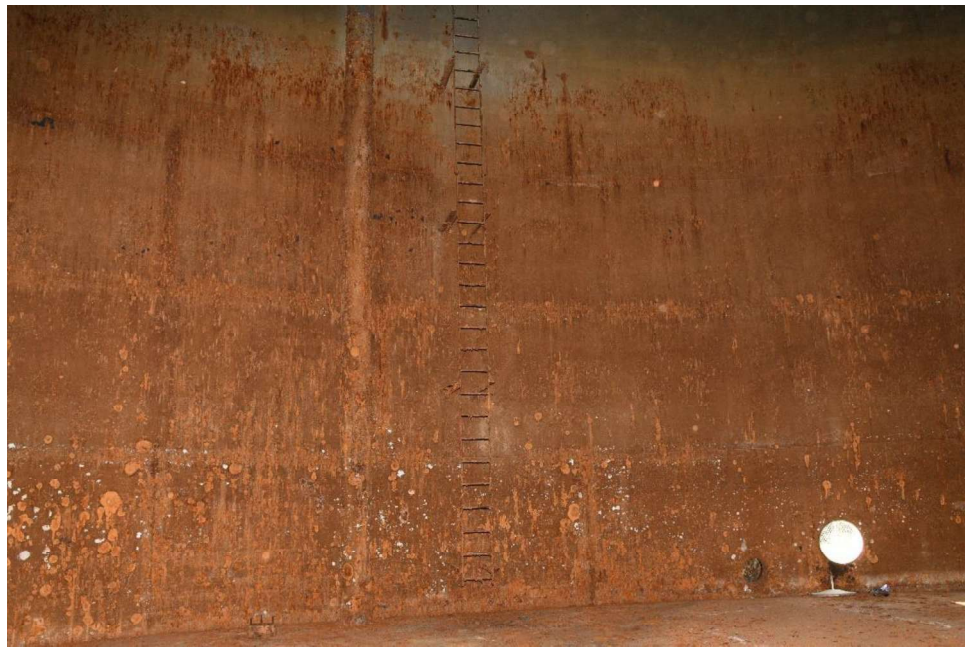
I-15 Same as Photo I-14, except at the bottom of the ladder and overflow.

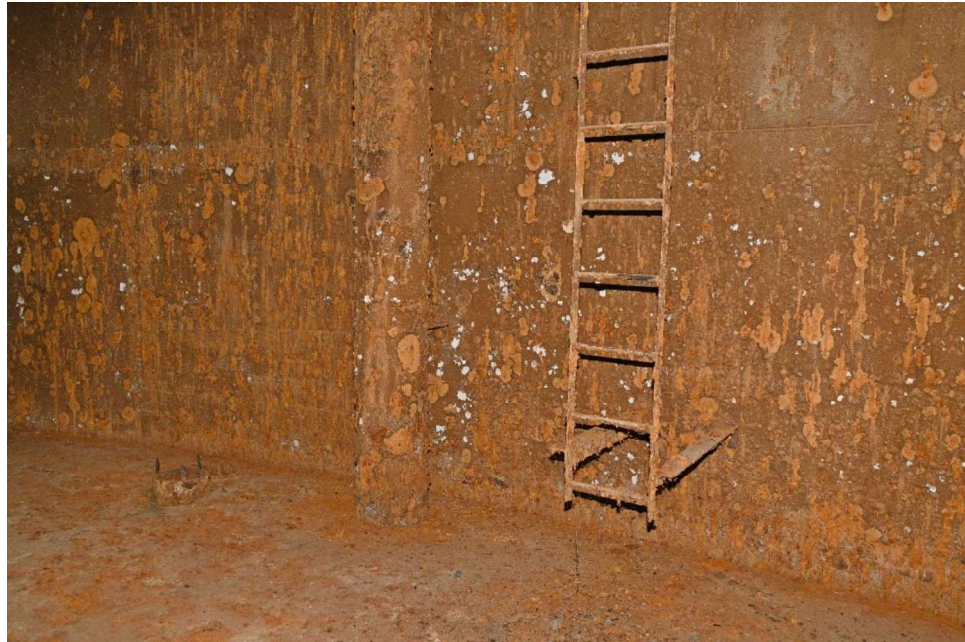
I-16 View of a portion of the shell, illustrating a layer of corrosion on all surfaces with random large rust tubercles present.

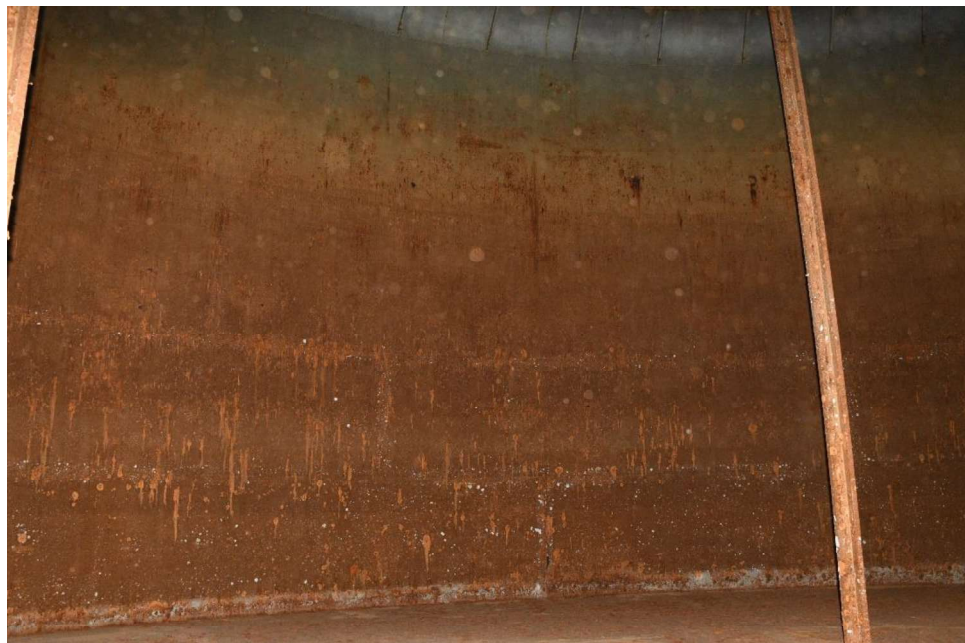
I-17 Same as Photo I-16, except in a different location.

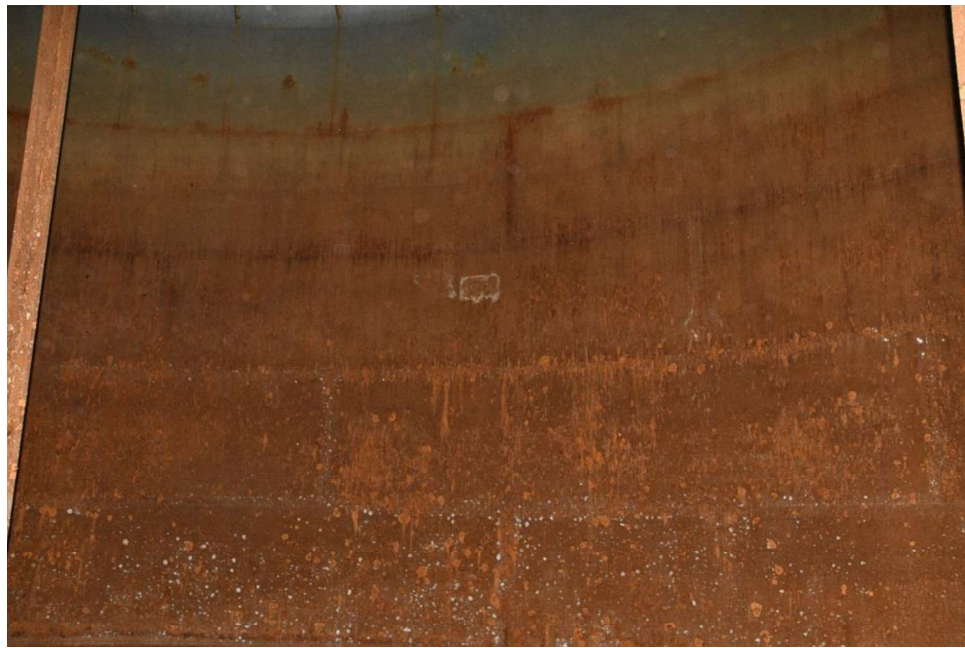
I-18 View of the manhole, illustrating blistering and corrosion on the adjacent shell. Note white spots where blisters have popped and exposed the steel substrate.

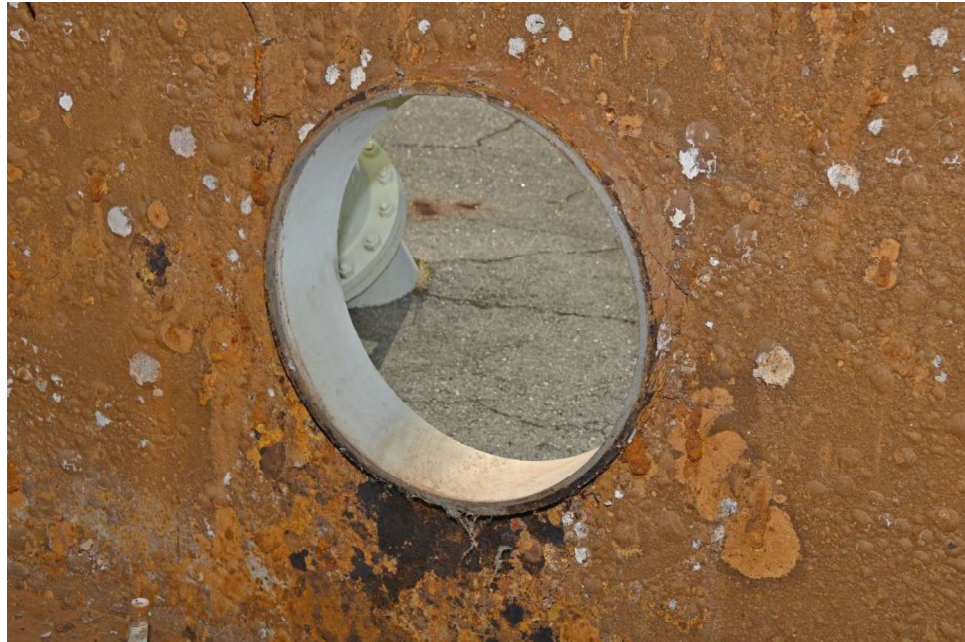
I-19 View of the manhole davit arm, illustrating a severely corroded davit arm and blistering and corrosion on the adjacent shell.

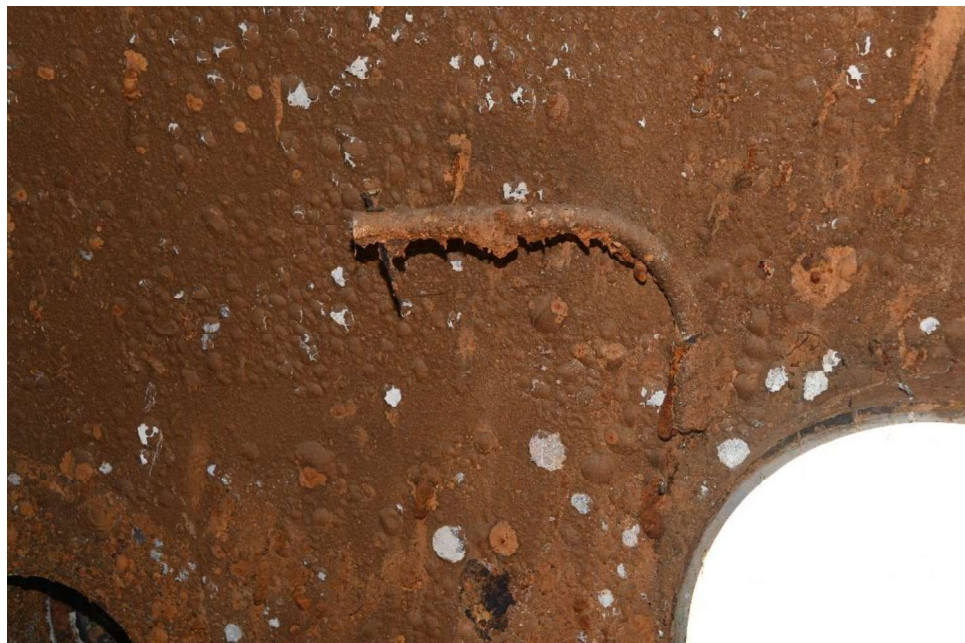
I-20 View of the inlet/outlet, illustrating blistering and corrosion on all surfaces.

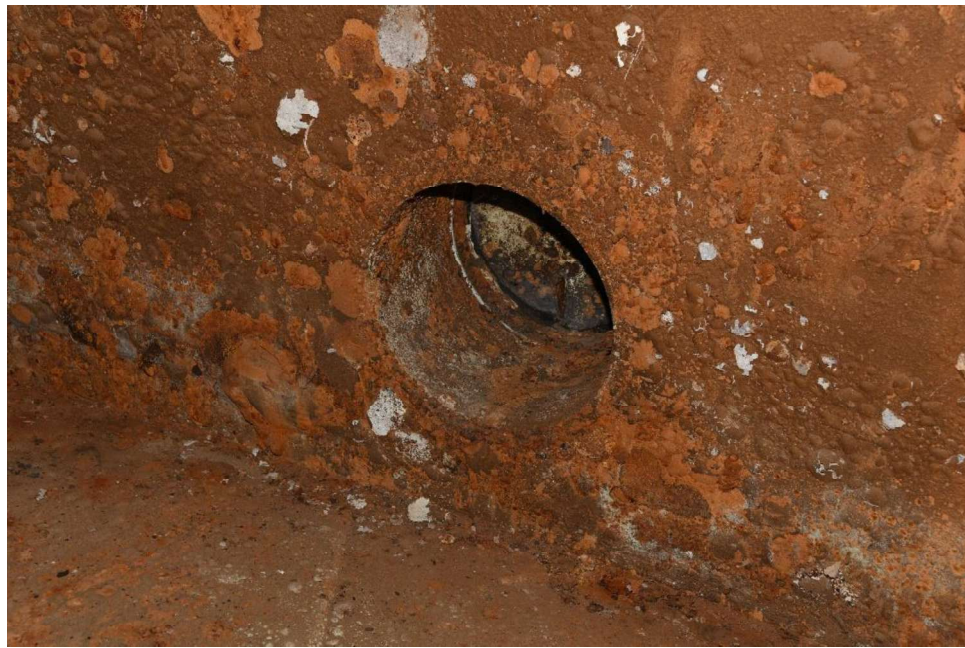
I-21 Same as Photo I-20, except at a small diameter penetration.

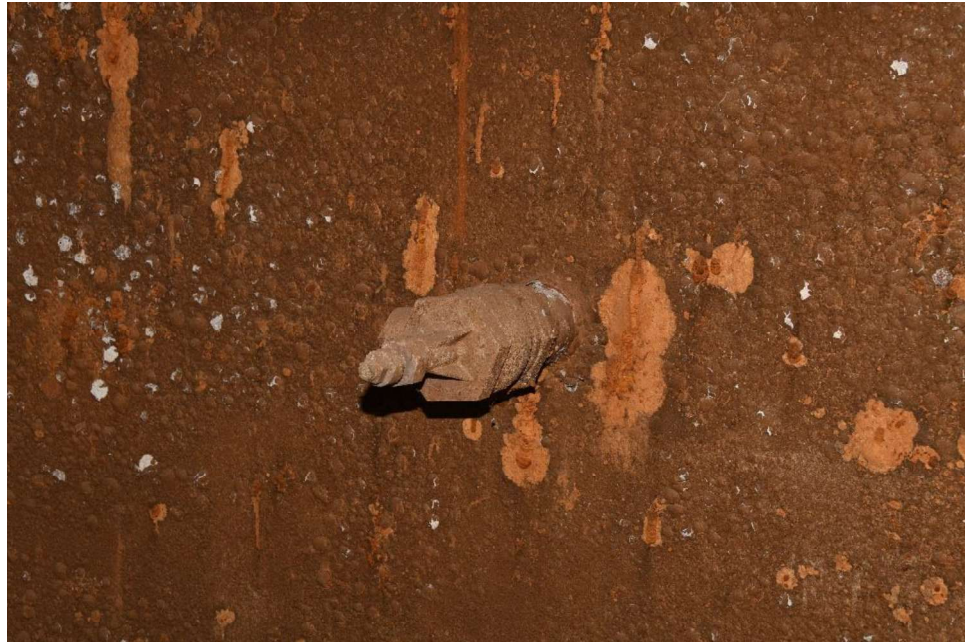
I-22 View of the shell to bottom transition, illustrating blistering, corrosion, and large rust tubercles on all surfaces.

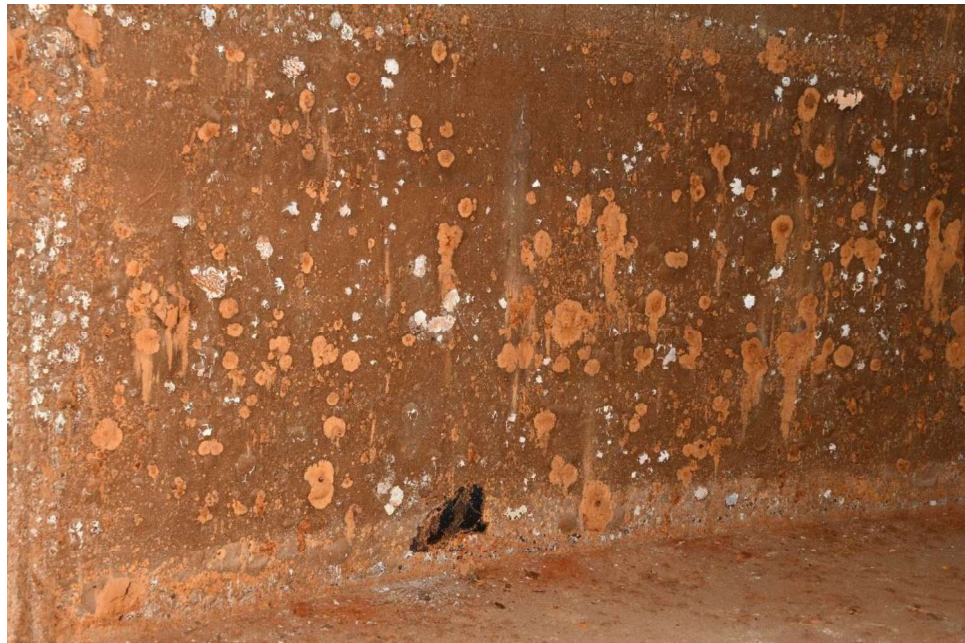
I-23 Close-up view of the shell, illustrating an area where blistering and corrosion were removed to examine the substrate. Note only minor etching and pitting of the substrate were found.

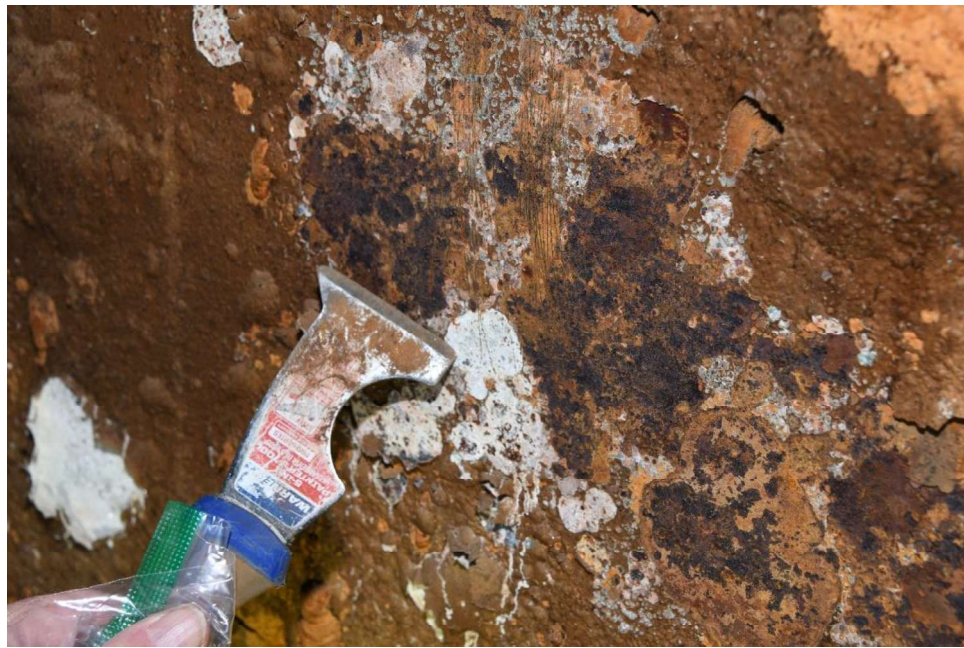
I-24 View of a column, illustrating delaminating coating with moderate to severe corrosion in the water fluctuation zone.

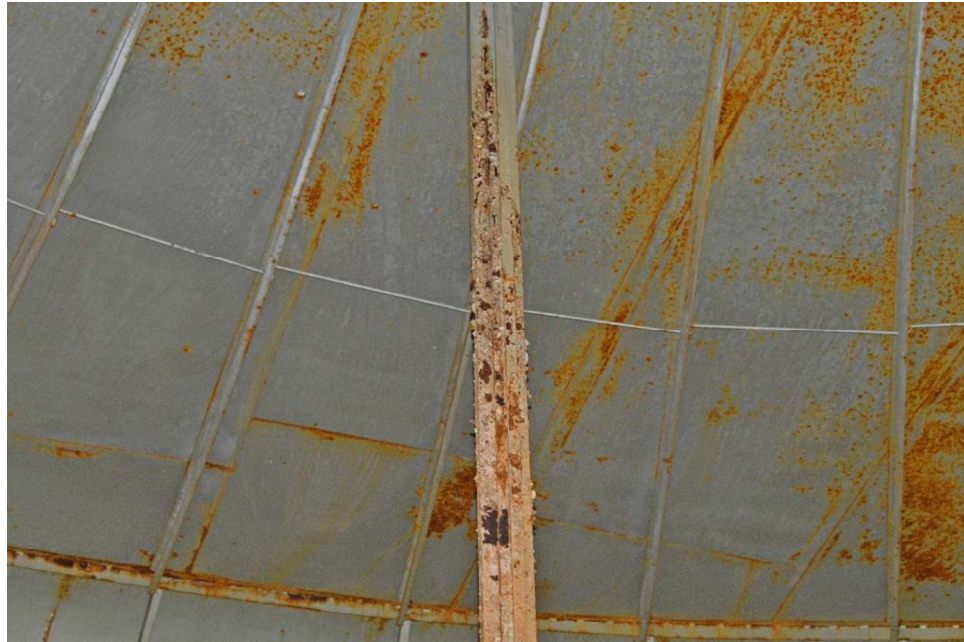
I-25 Same as Photo I-24, except at a different column.

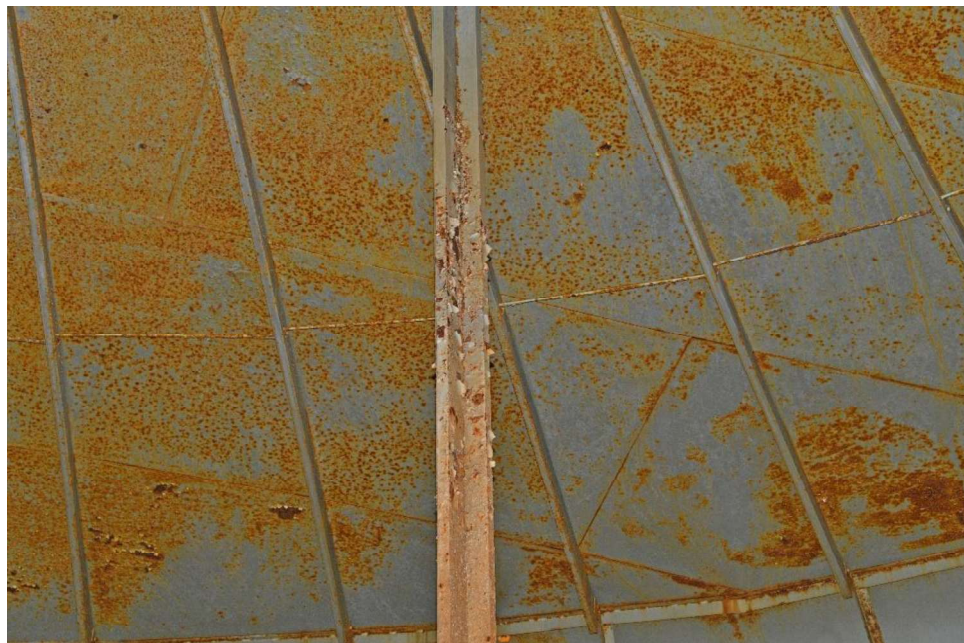
I-26 View of a column base, illustrating blistering, delaminating coating, and corrosion on the column and channel base.

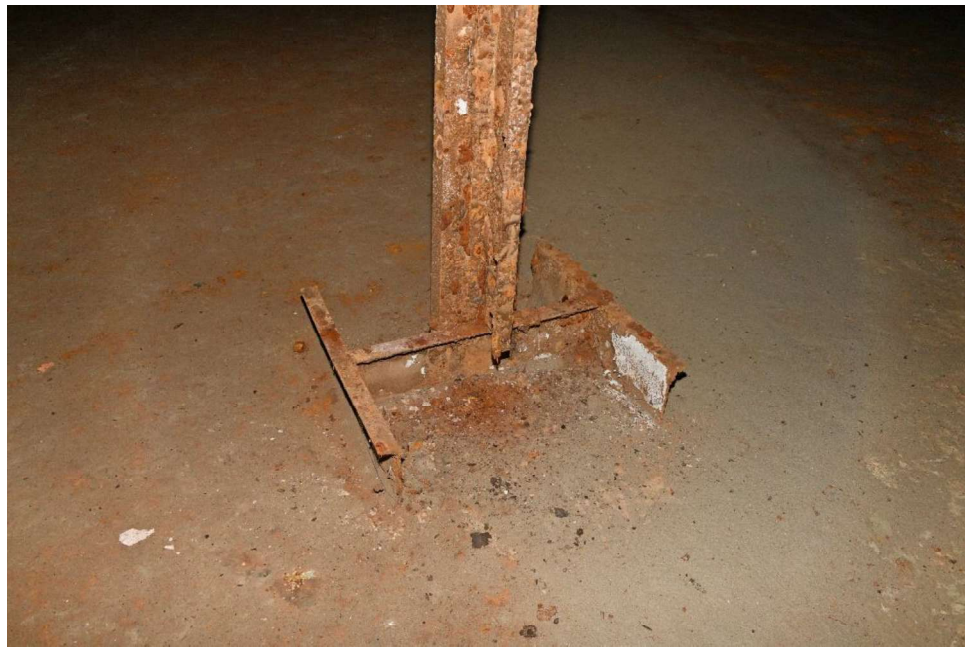
I-27 Same as Photo I-26, except at a different column.

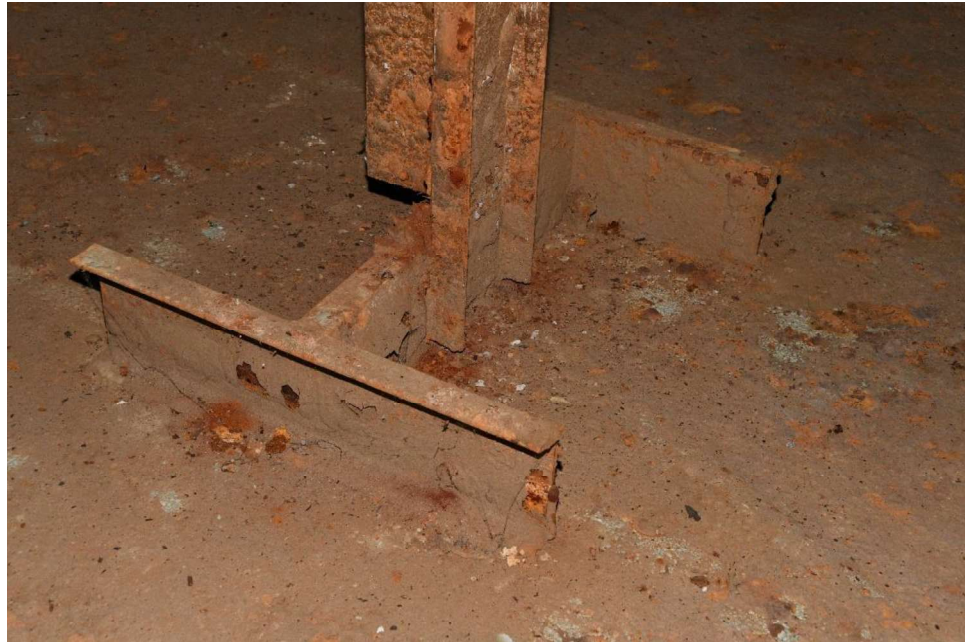
I-28 View of the bottom, illustrating moderate to severe corrosion on all surfaces.

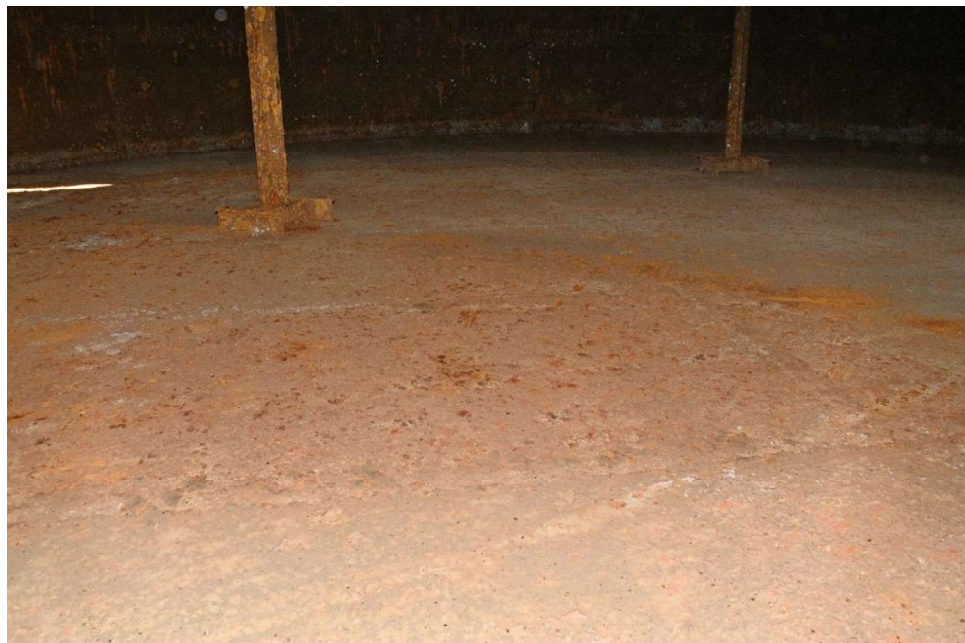
I-29 Same as Photo I-28, except in a different location.

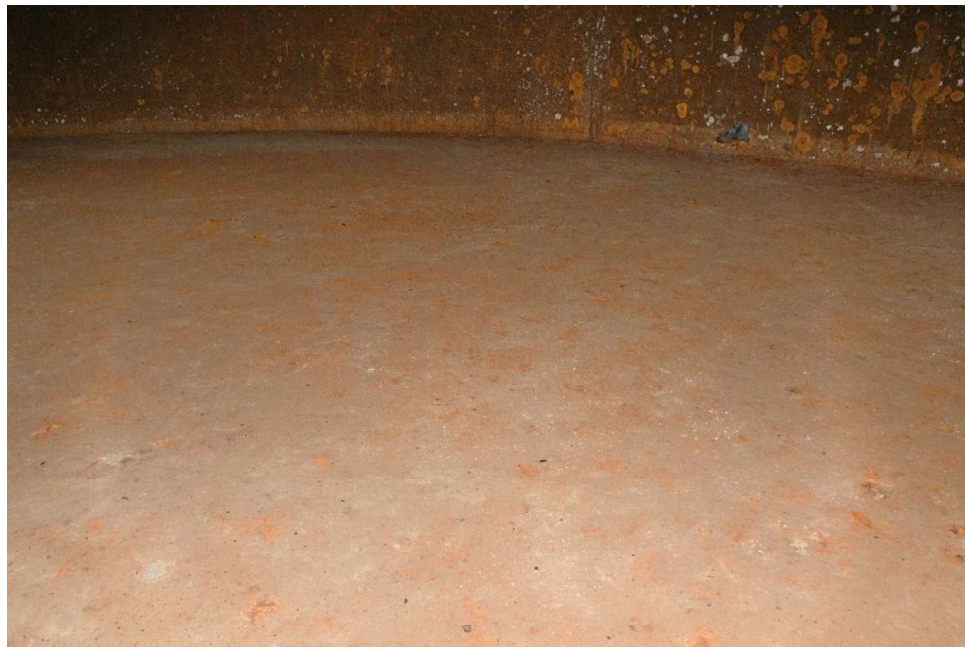
I-30 Close-up view of the bottom, illustrating rust scale that has been removed to examine the substrate. Note moderate to severe pitting is present in this area.

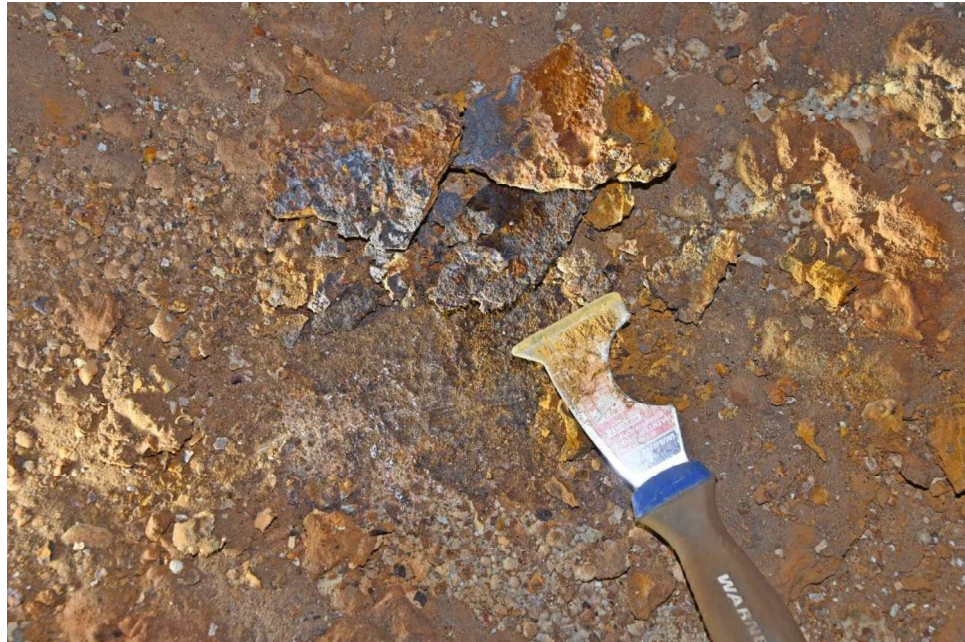
I-31 View of the drain, illustrating moderate corrosion on the interior of the pipe and blistering and corrosion on the adjacent bottom plates.
